# opticalCON QUAD | **Technical Paper**

Mechanical, electrical and optical tests applied to the opticalCON transmission system for Pro Audio / Video and Broadcast purposes with main focus on changes in attenuation.

This documentation describes the results of the test series conducted at Neutrik AG, University of Applied Sciences of Technology Buchs NTB

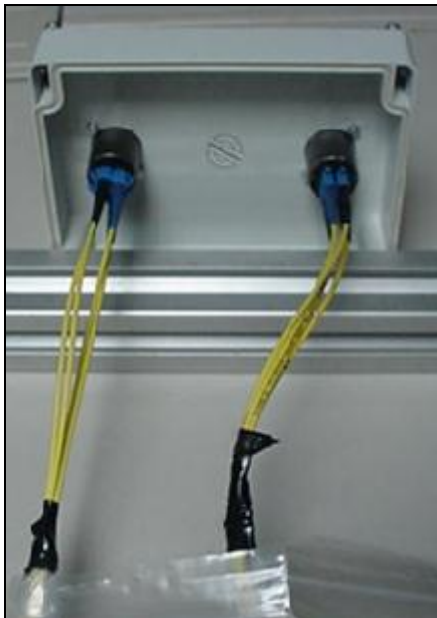
Fig. 2.b

The measurement cables are covered with a plastic bag to avoid pollution on powermeter.

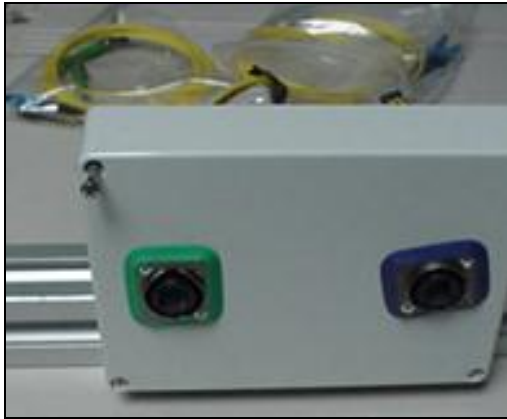
Fig. 2.c

Figure 2.f and 2.g exhibit two opticalCON chassis NO4FDW with silicon gaskets SCDP\*. On the rear side there are standard single-mode LC/LC patch cables plugged. To avoid dust on the ferrules, the unconnected LCs are sealed with a plastic bag.

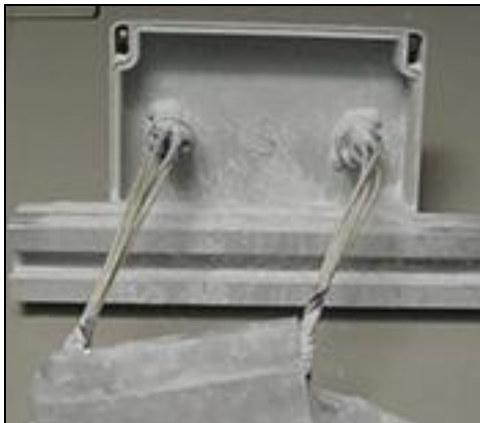
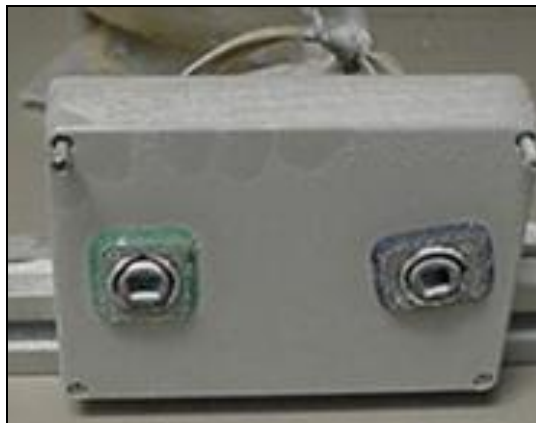
After dust test: The opticalCON QUAD chassis NO4FDW are completely covered with talcum particle on the front and rear side (fig. 2.d and 2.e). The measured attenuation (figure 2.a) establishes only small variation of the attenuation values after dust test.

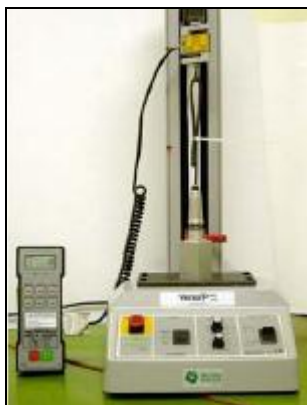
Fig 4.a

Full automatic cable retention test according IEC 61300-2-4  
The pulling force went over >500 N

The opticalCON QUAD cable is tested and approved for > 500N without any quality and function adverse effects.

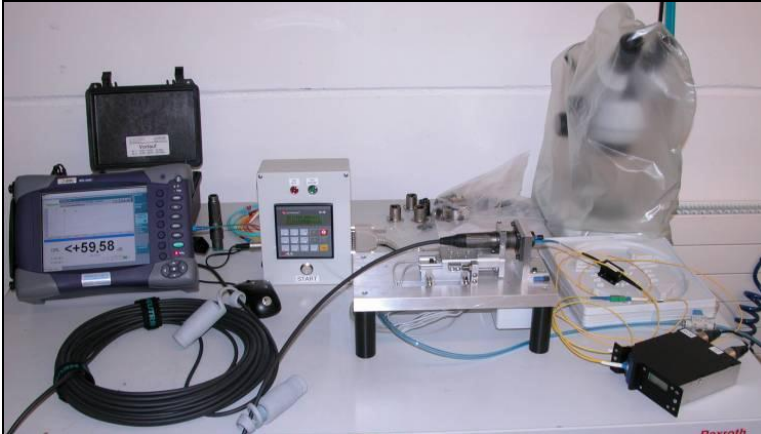
Fig. 7.a: measuring setup for durability and lifetime test

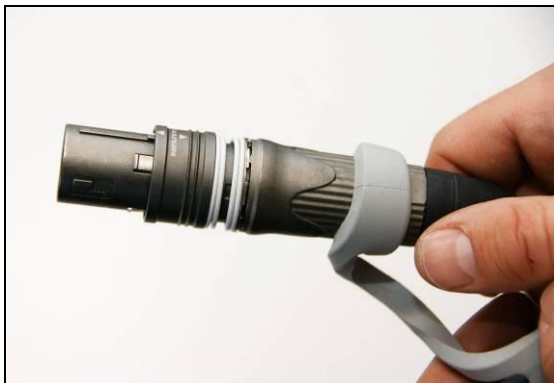
Fig. 7.g

No mechanical degradations on the opticalCON QUAD cable connector.

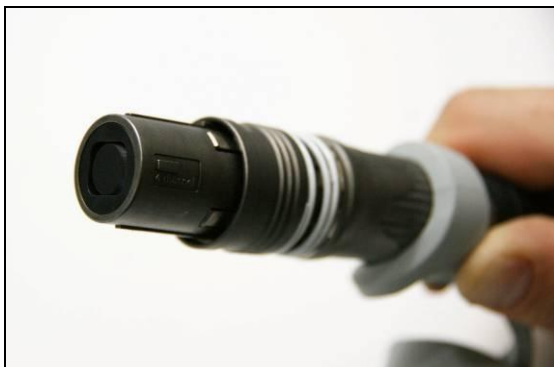
Fig. 7.h

Proper functionality of the shutter and locking mechanism

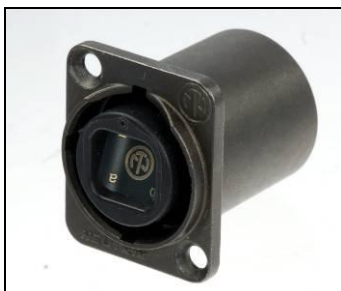
Fig. 8: Test chassis NO4FDW-R

After 5000 mating cycles and temperature test the opticalCON chassis NO4FDW-R (figure 14) didn't show any significant deformations or mechanical malfunction. The greased O-ring didn't indicate any cracks or rough areas (figure 15).

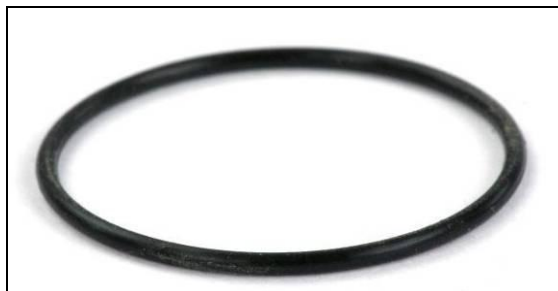
Fig. 9: O-ring after 5000 mating cycles
